STRUCTURAL EVALUATION
OF THE
BERKELEY SCHOOLS
FOR THE
BERKELEY UNIFIED SCHOOL DISTRICT

FEBRUARY, 1991

BUSD STRUCTURAL EVALUATION

INTRODUCTION

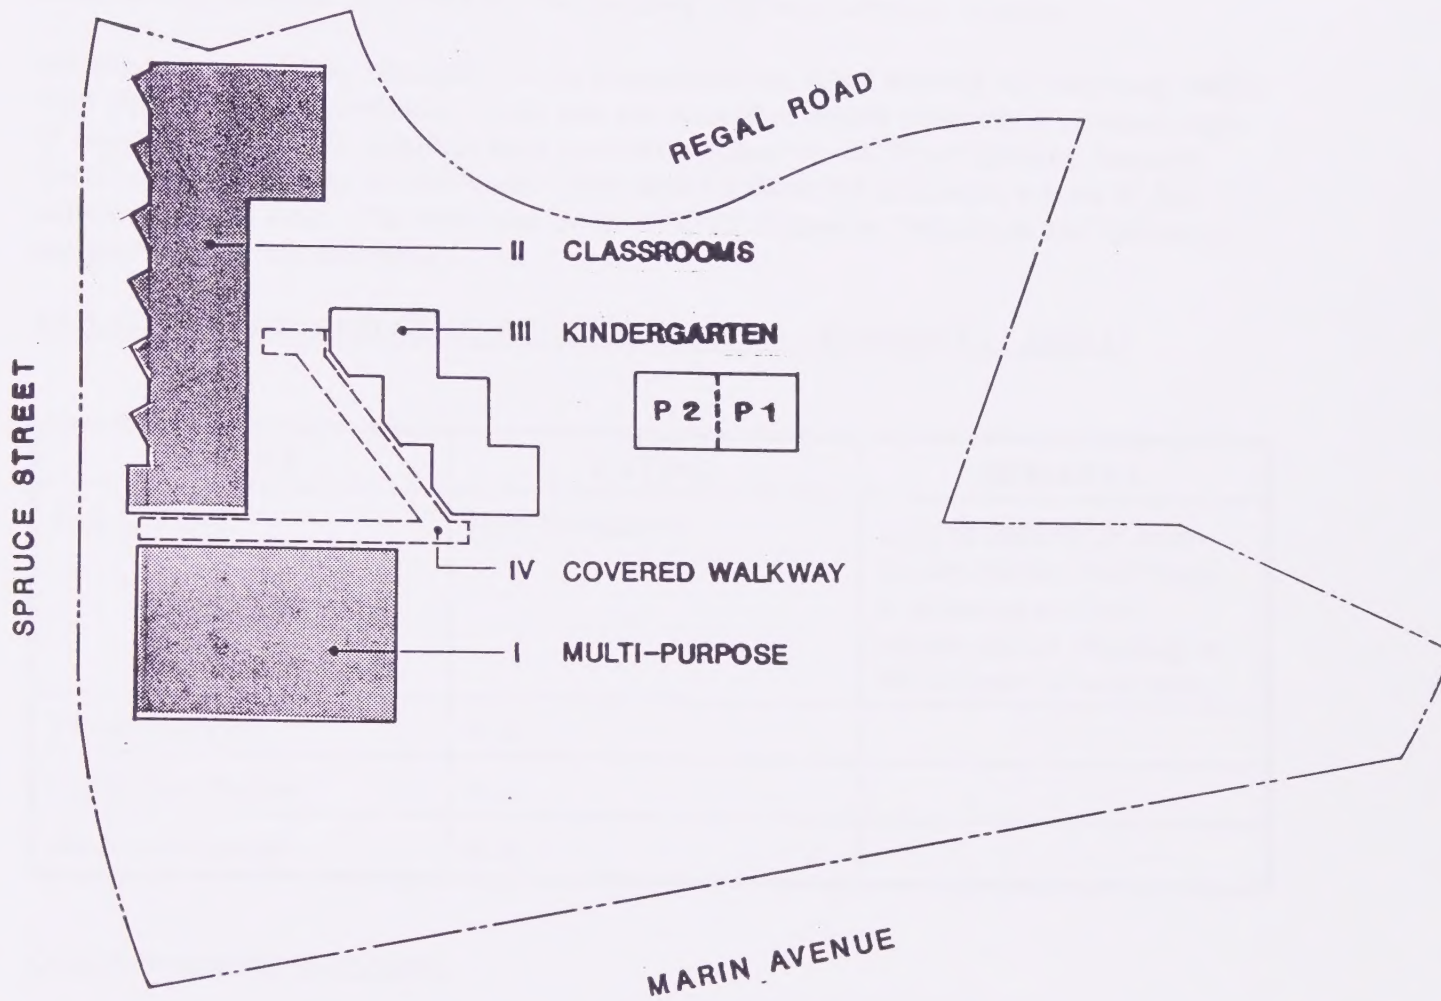
SITE PLAN

INDICATES AREAS WHERE HAZARD POTENTIAL HAS BEEN NOTED

EVENT	RATING	REMARKS
Full Collapse	High Probability	Lack of ductility in beam column frames could lead to progressive brittle column failure resulting in full collapse of structures.
Partial Collapse	N.A.	
Component Failure	N.A.	
Blocked Entrance	N.A.

Both the multipurpose building and classroom building are of non-ductile concrete frame construction. This type of construction is characterized by sudden brittle catastrophic failure under earthquake loading, and is no longer permitted by Code.

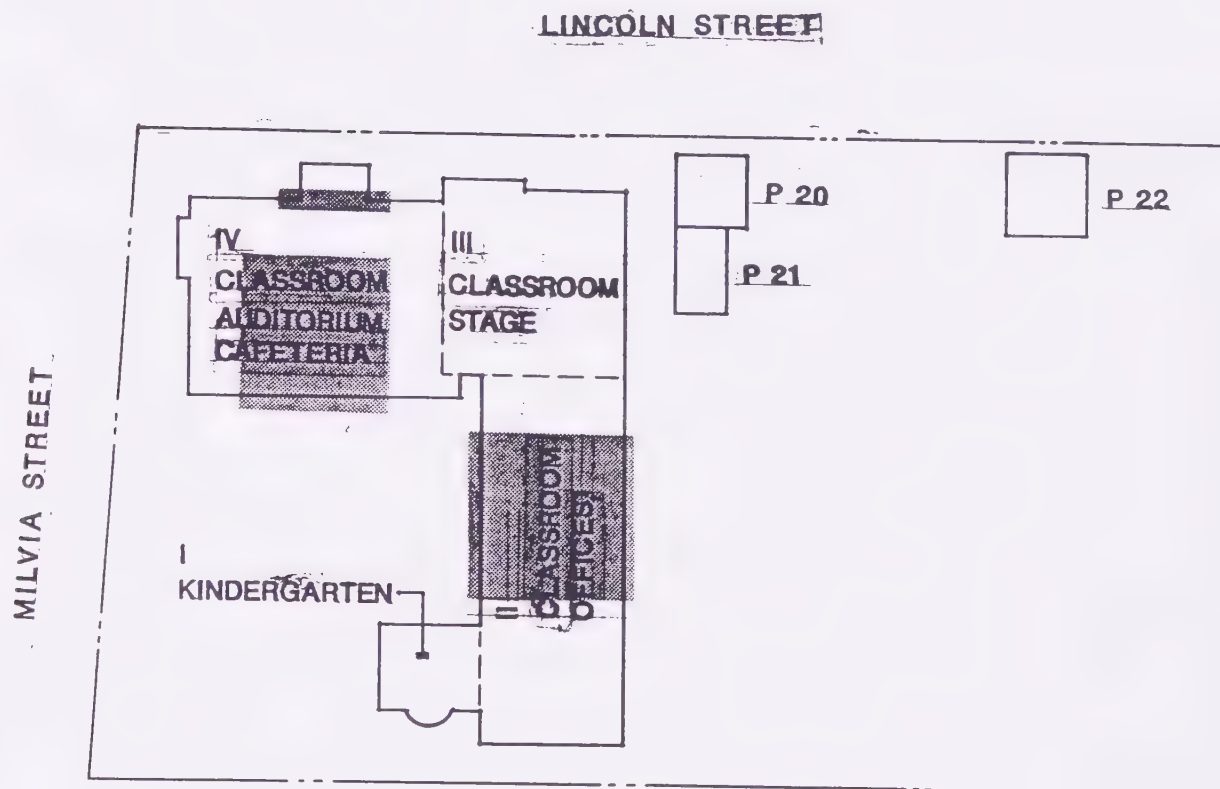
SITE PLAN

INDICATES AREAS WHERE HAZARD POTENTIAL HAS BEEN NOTED

EVENT	RATING	REMARKS
Full collapse	Low Probability	Low hazard potential due to shear wall construction
Partial collapse	Low to Moderate Probability	Moderate hazard potential. Possible loss of support at certain columns.
Component failure	High Probability	High hazard potential. Possible fracturing of concrete at column-beam connections.
Blocked entrance	Low to Moderate Probability	Moderate hazard potential. Falling debris could impair egress.

Shear wall construction reduces the possibility of full collapse, but the flexibility of the horizontal diaphragms may allow large deflections in a strong earthquake. Deflections could result in loss of support and partial collapse at certain column locations. However, it is our opinion that partial collapse is unlikely, as columns at the second floor are lightly loaded. It is more likely that the damage would be limited to fracturing of concrete at the beam-column location, which could result in localized falling hazards (pieces of concrete up to volleyball size).

One concrete beam to shear wall connection which could sustain damage is at a corridor location. Thus there is a moderate probability for component failure, with the possibility of impeded egress.

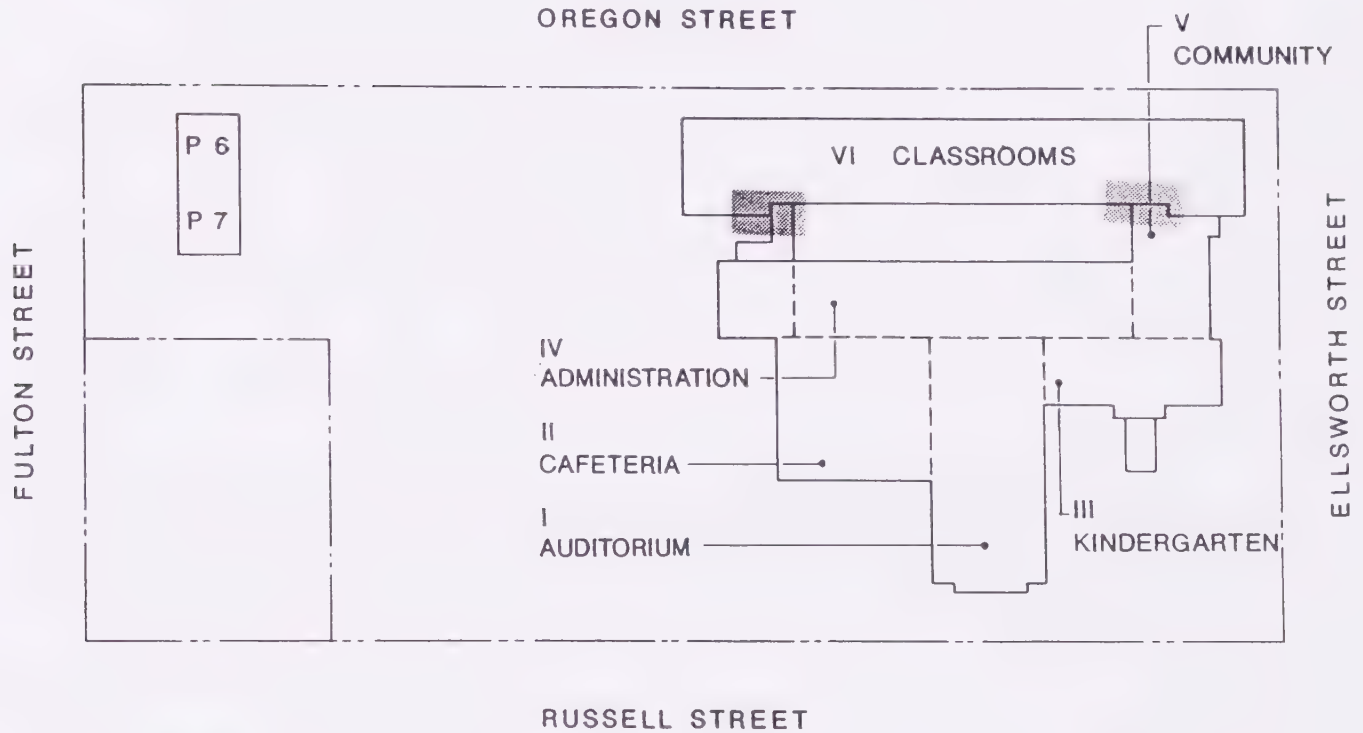
SITE PLAN

INDICATES AREAS WHERE HAZARD POTENTIAL HAS BEEN NOTED

EVENT	RATING	REMARKS
Full Collapse	Not Probable	---
Partial Collapse	Not Probable	---
Component Failure	Moderate Probability	Low hazard potential from falling debris.
Blocked Entrance	Not Probable	---

Because the six building elements are tied together an undesirable torsional situation results. This could result in spalling of reinforced concrete members in the East Corridor and Cloister roof structures at their connections to the Element VI, Classroom Building during a strong earthquake. No collapse or partial collapse is anticipated.

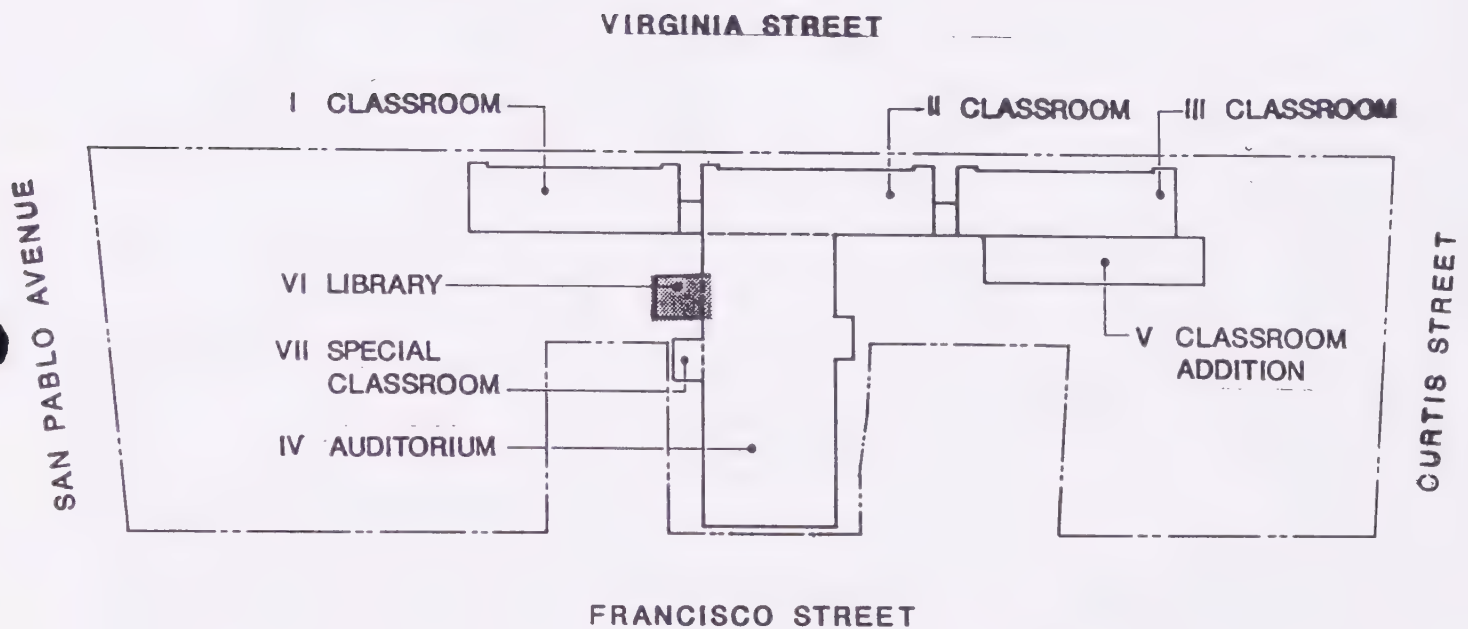
SITE PLAN

INDICATES AREAS WHERE HAZARD POTENTIAL HAS BEEN NOTED

EVENT	RATING	REMARKS
Full Collapse	Not Probable	---
Partial Collapse	Low Probability	Loss of column support is not expected. Low hazard potential.
Component Failure	Low Probability	Low hazard potential from spalling concrete.
Blocked Entrance	Low Probability	Vulnerable components not located at exits.

All of the above suspected deficiencies were found to be satisfactory by a more detailed analysis, with the exception that reinforced concrete columns and beams do not meet ductility requirements. It is not expected, however, that the deformations to which these columns will be subjected will cause them to fail.

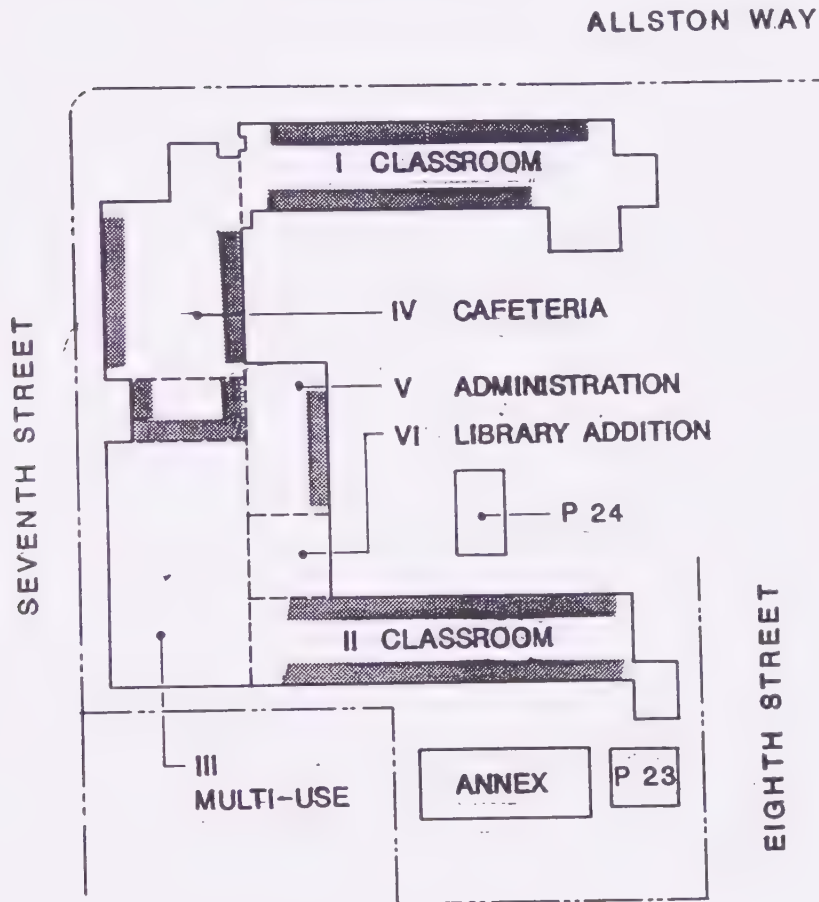
INDICATES AREAS WHERE HAZARD POTENTIAL HAS BEEN NOTED

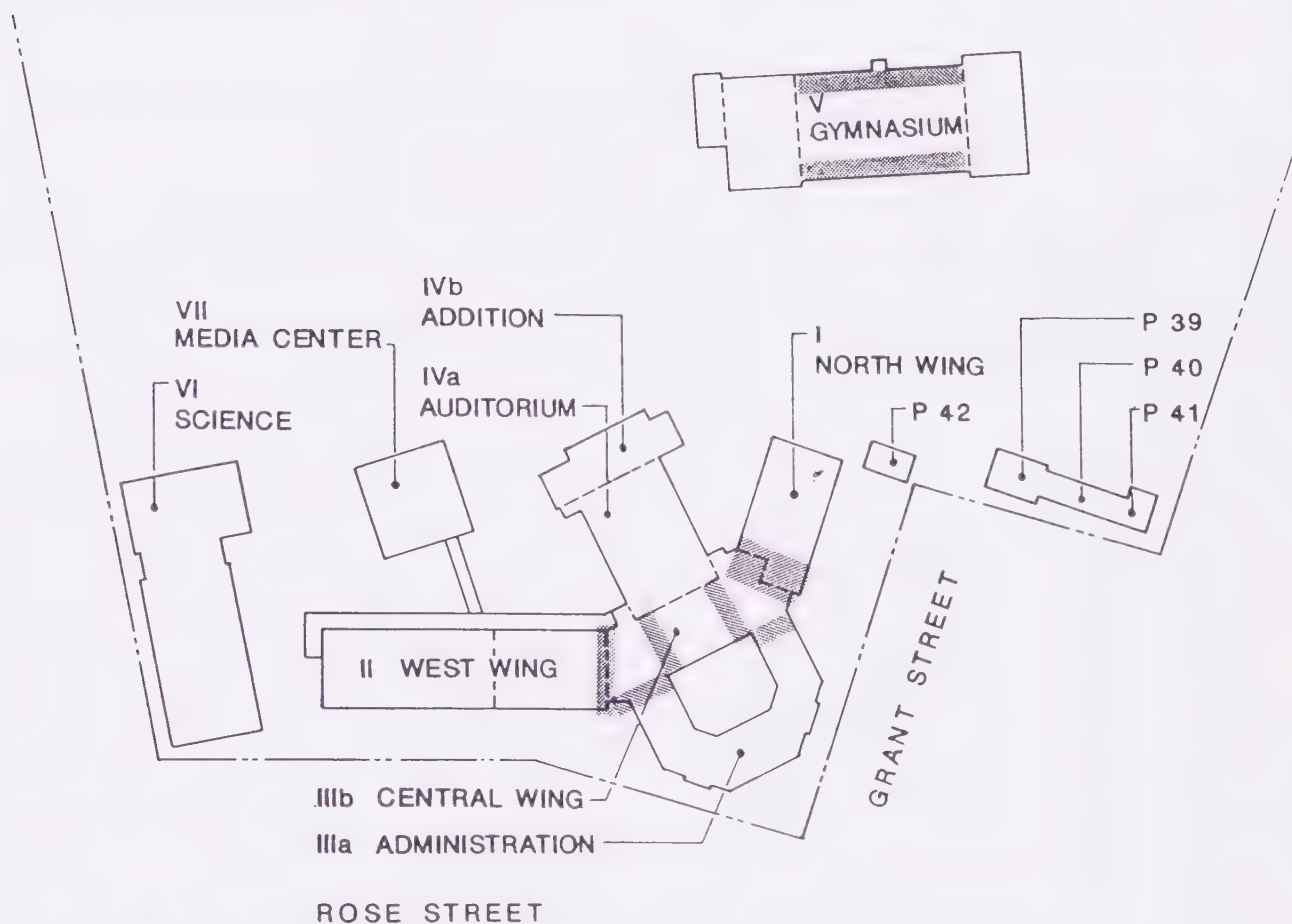
INDICATES AREAS WHERE HAZARD POTENTIAL HAS BEEN NOTED

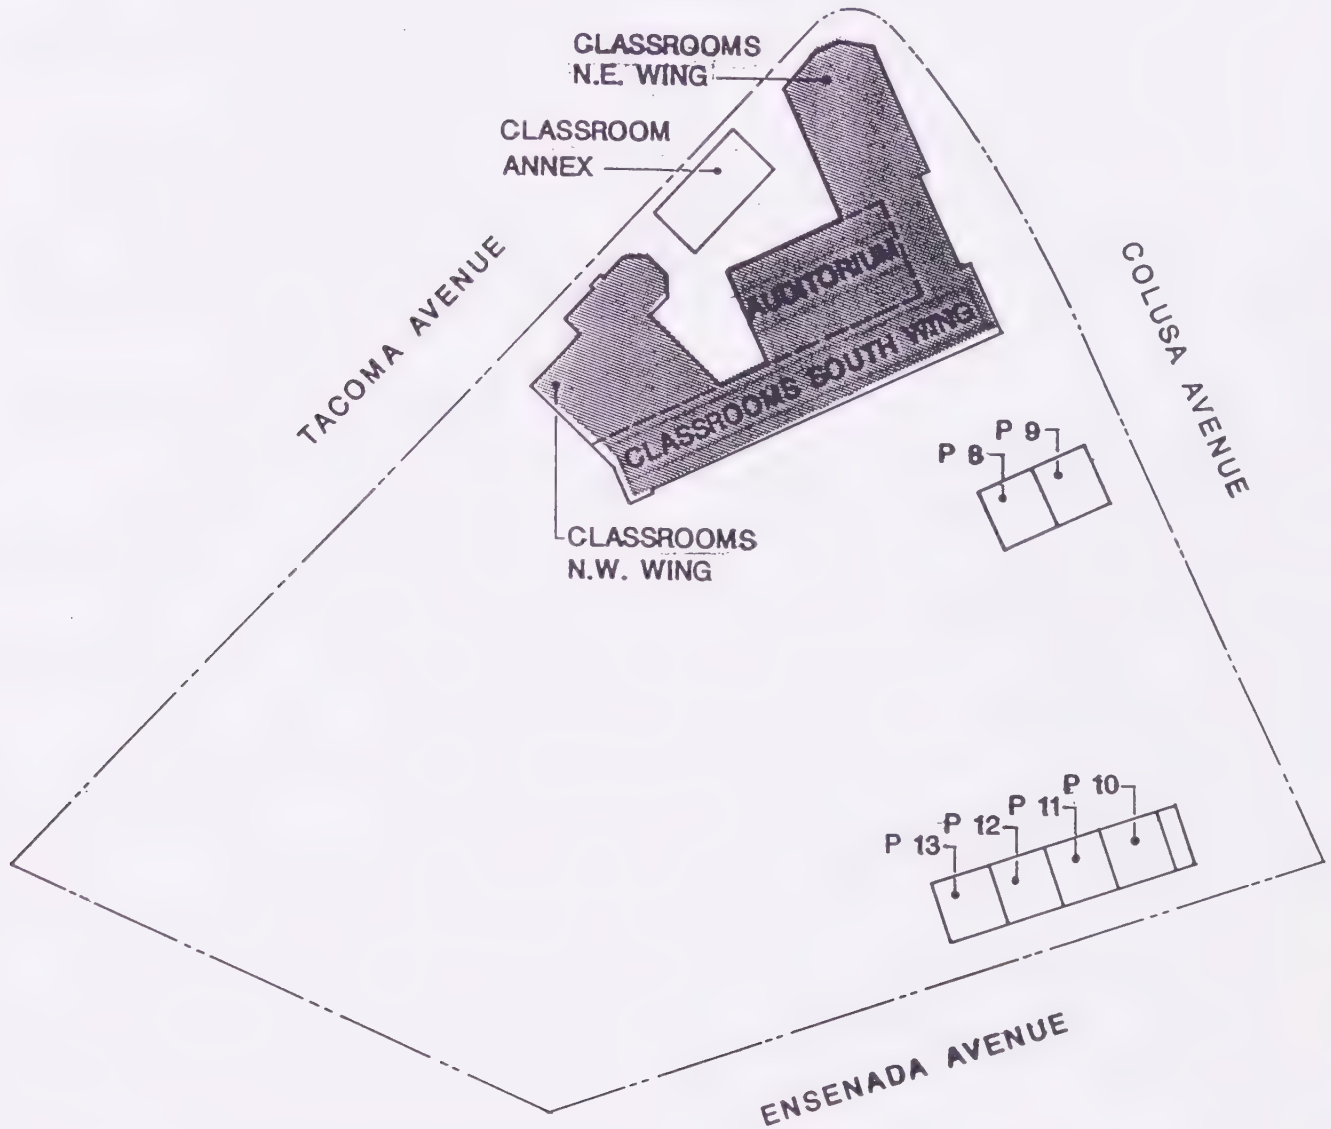
SITE PLAN

INDICATES AREAS WHERE HAZARD POTENTIAL HAS BEEN NOTED

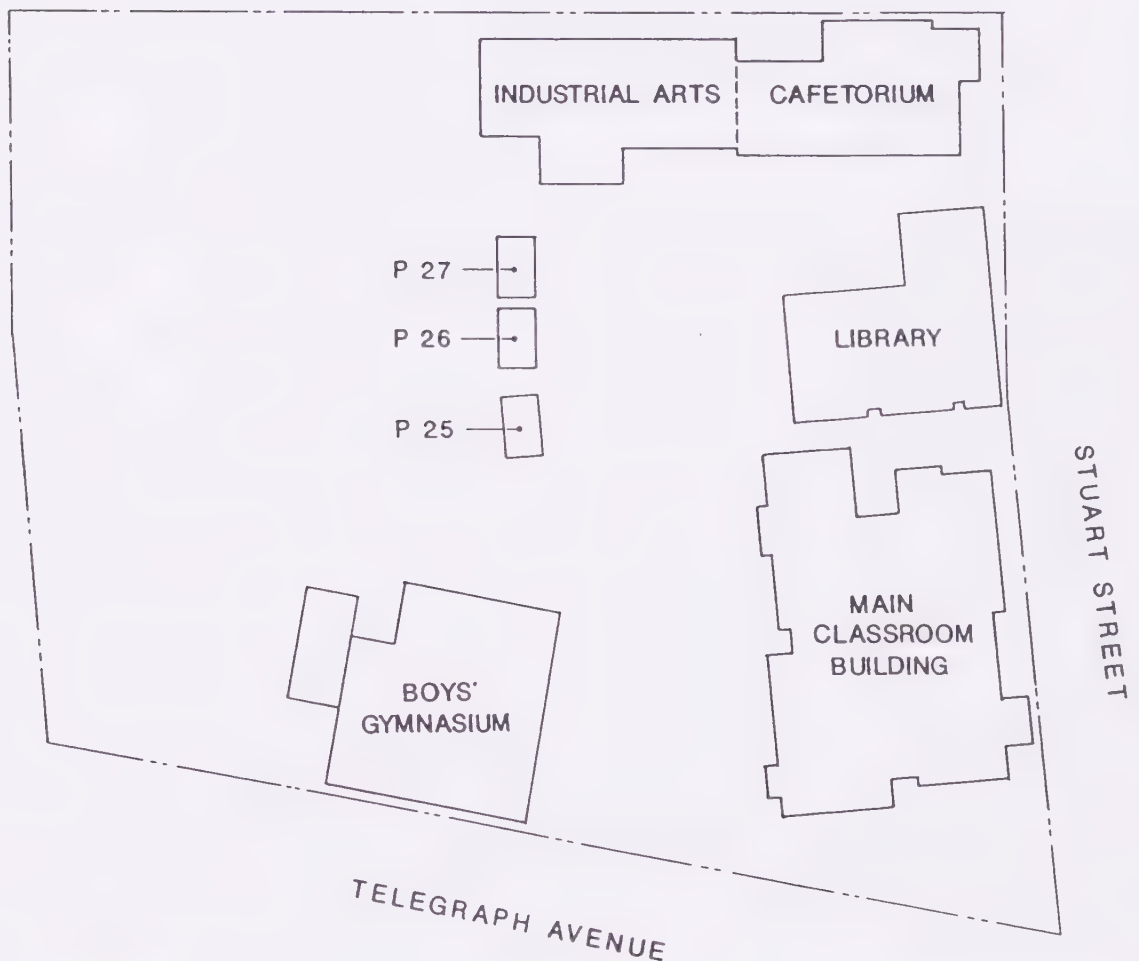
SITE PLAN

INDICATES AREAS WHERE HAZARD POTENTIAL HAS BEEN NOTED

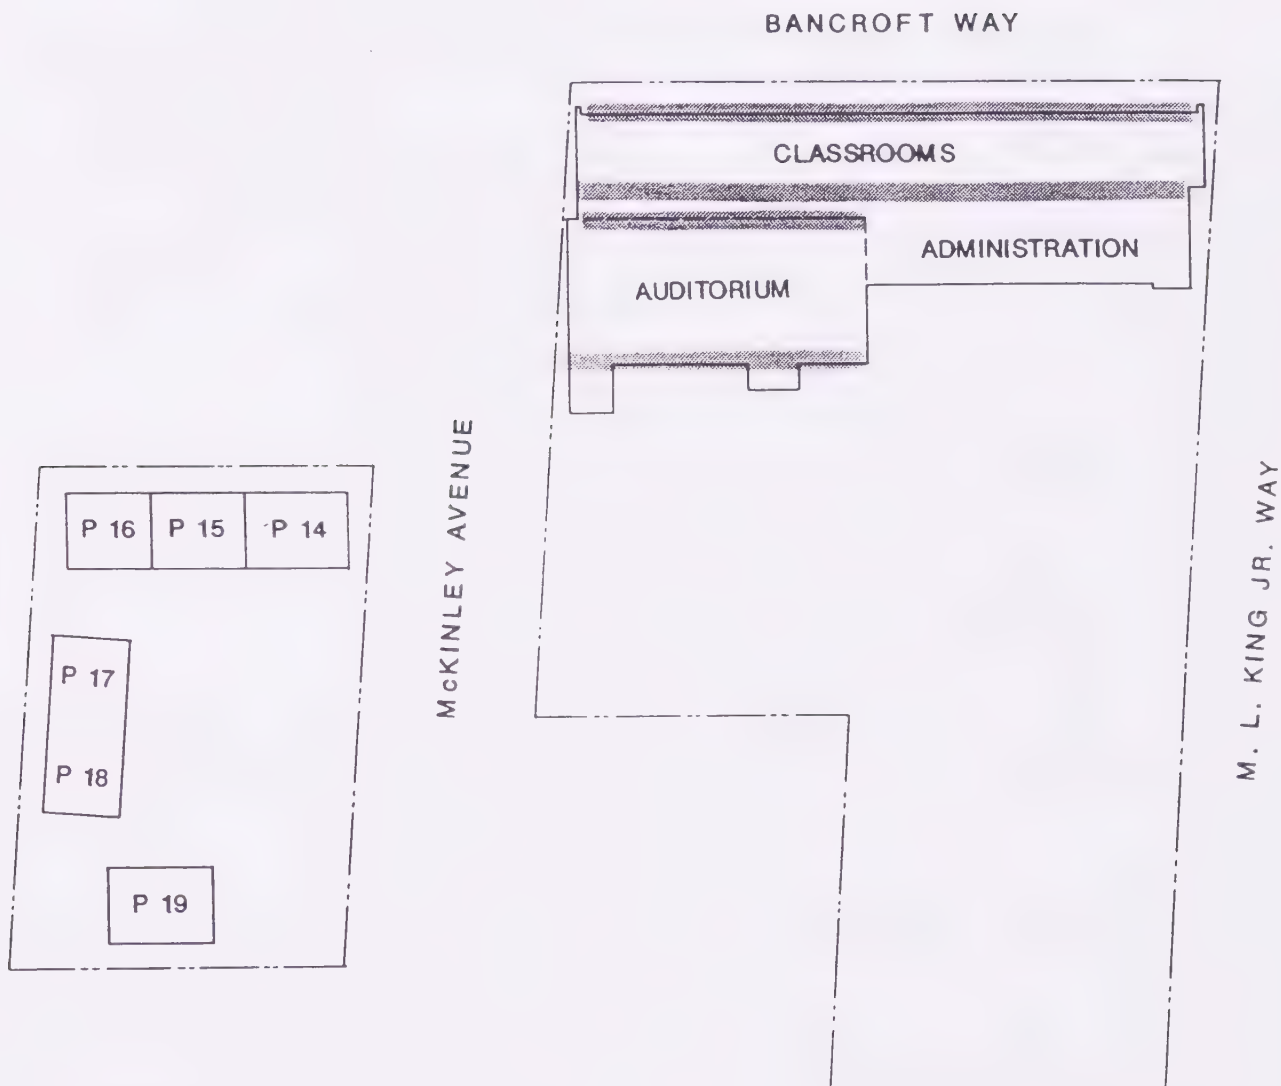
SITE PLAN

INDICATES AREAS WHERE HAZARD POTENTIAL HAS BEEN NOTED

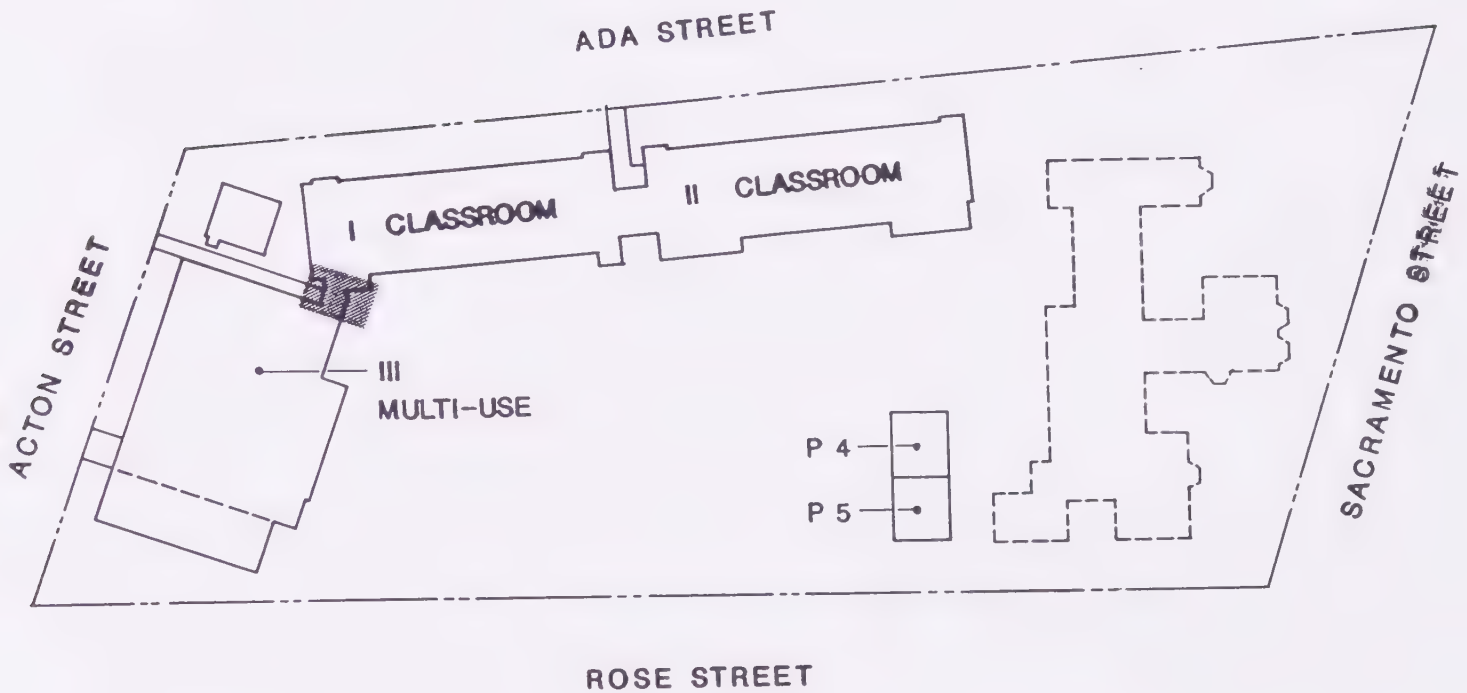
SITE PLAN

INDICATES AREAS WHERE HAZARD POTENTIAL HAS BEEN NOTED

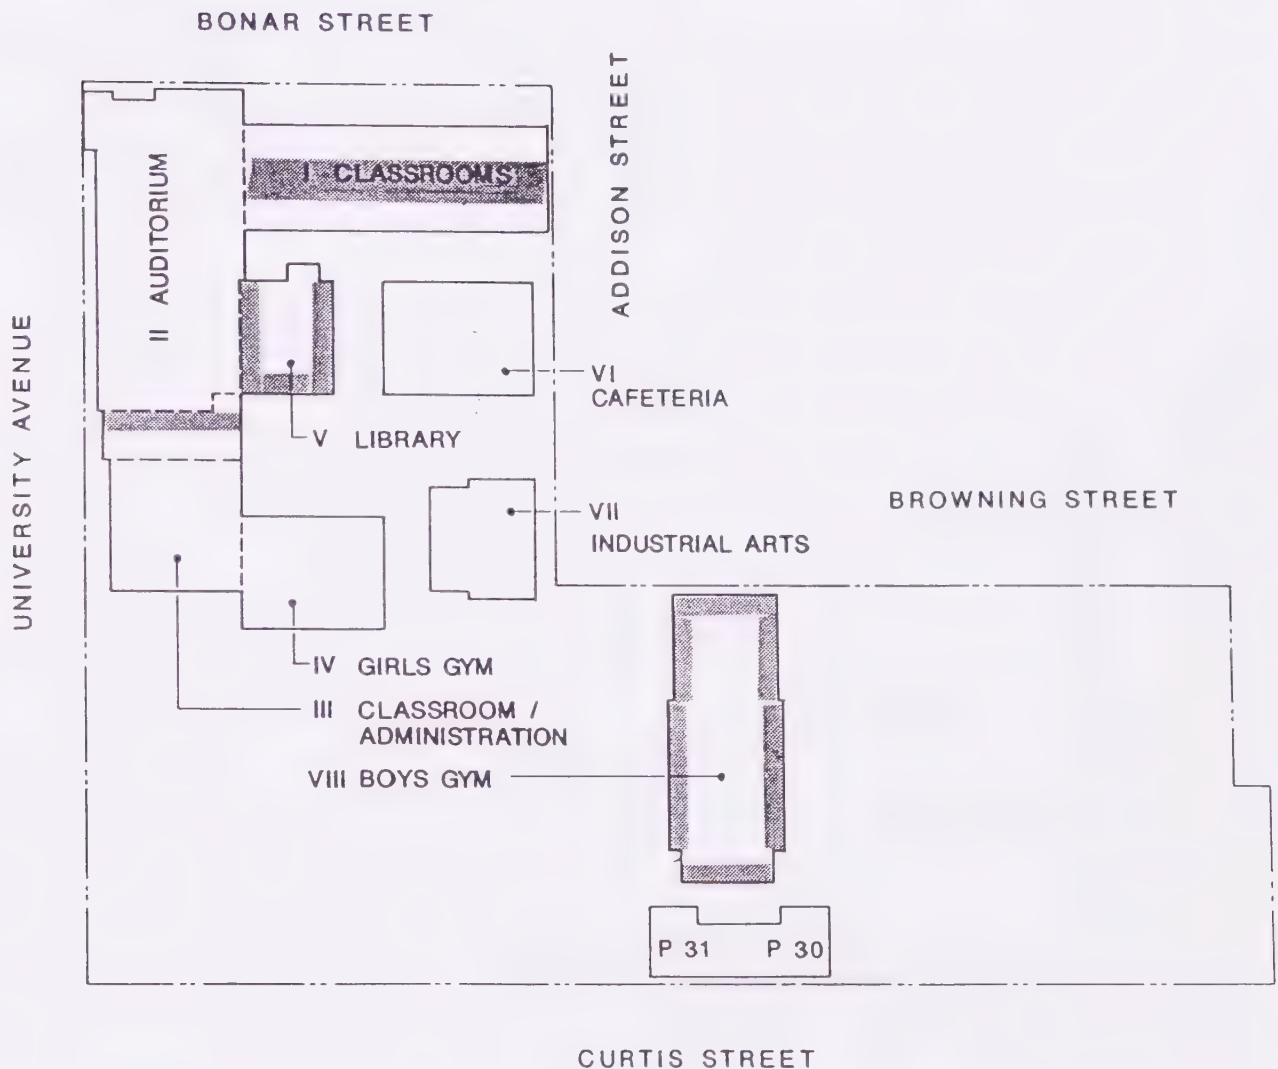
SITE PLAN

INDICATES AREAS WHERE HAZARD POTENTIAL HAS BEEN NOTED

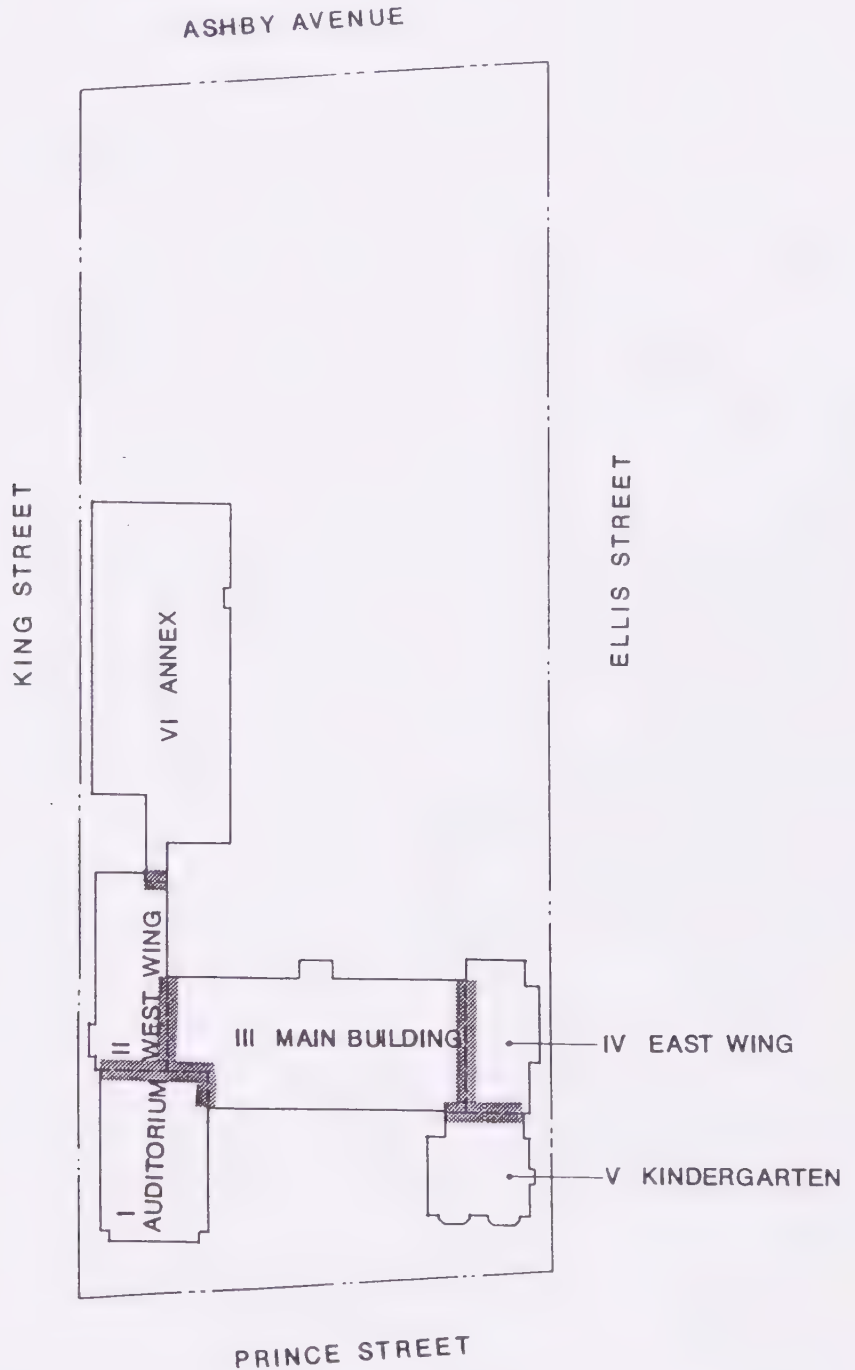
INDICATES AREAS WHERE HAZARD POTENTIAL HAS BEEN NOTED
